## **Drum Discovery, Handling, and Disposal**

**Clean Harbor's - Wichita, KS**

**March 23, 2015**

Previously unidentified and unknown buried drums were encountered during excavations at the Clean Harbor's Facility in Wichita, KS.

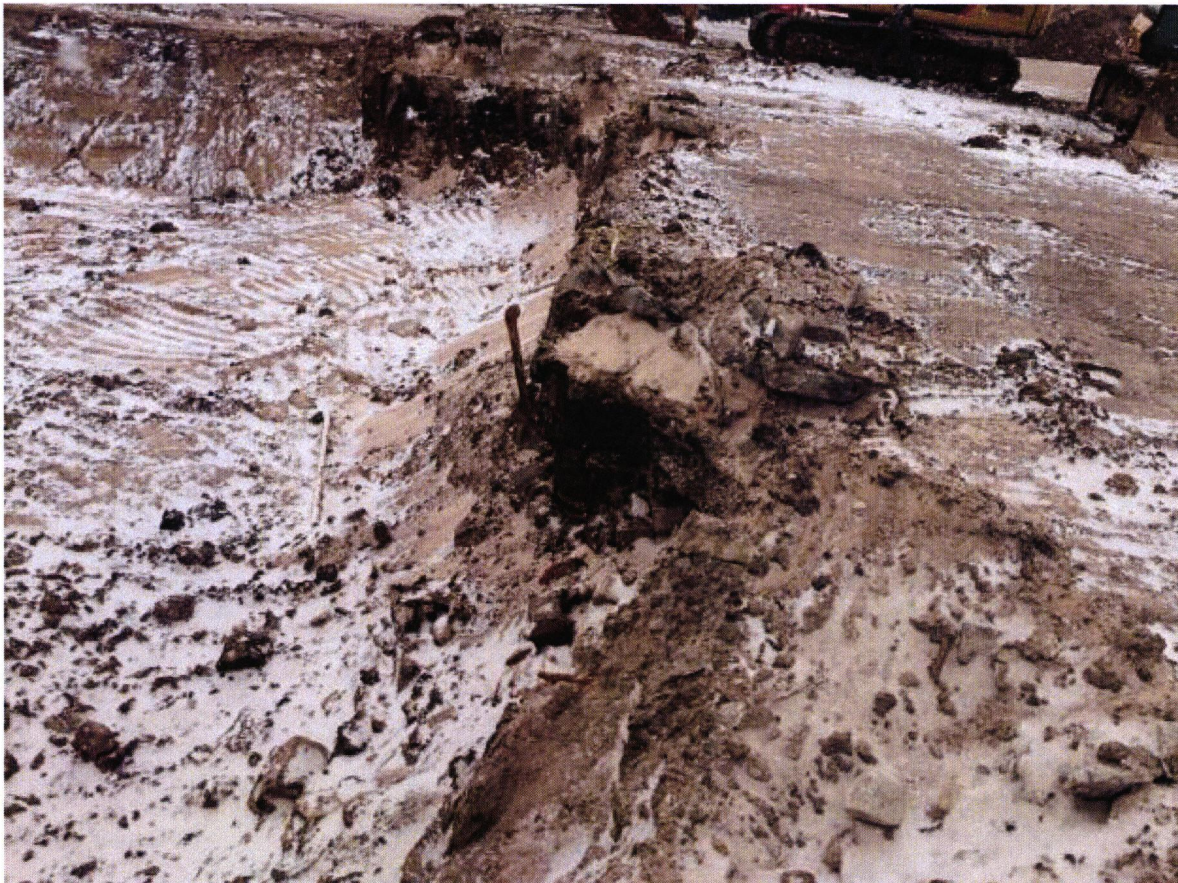
Looking South, the photo above shows one drum and rubble in place prior to removal on December 30, 2014. The drum was located near the western extent of the Process Area excavation.

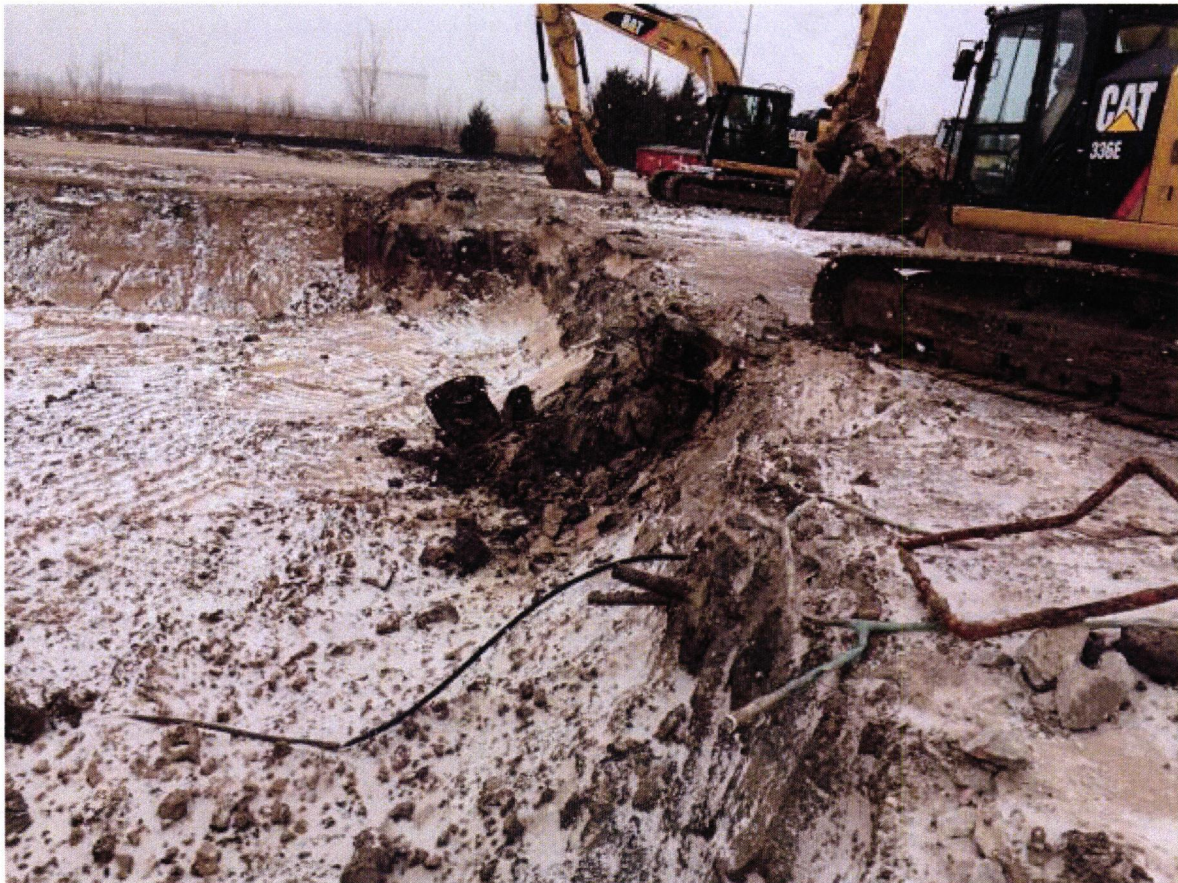
Looking South, the photo above shows the drum and rubble being removed. Upon excavation, a total of 3 drums were present. Of the 3 drums, 2 drums were crushed while one drum retained its general shape and size.

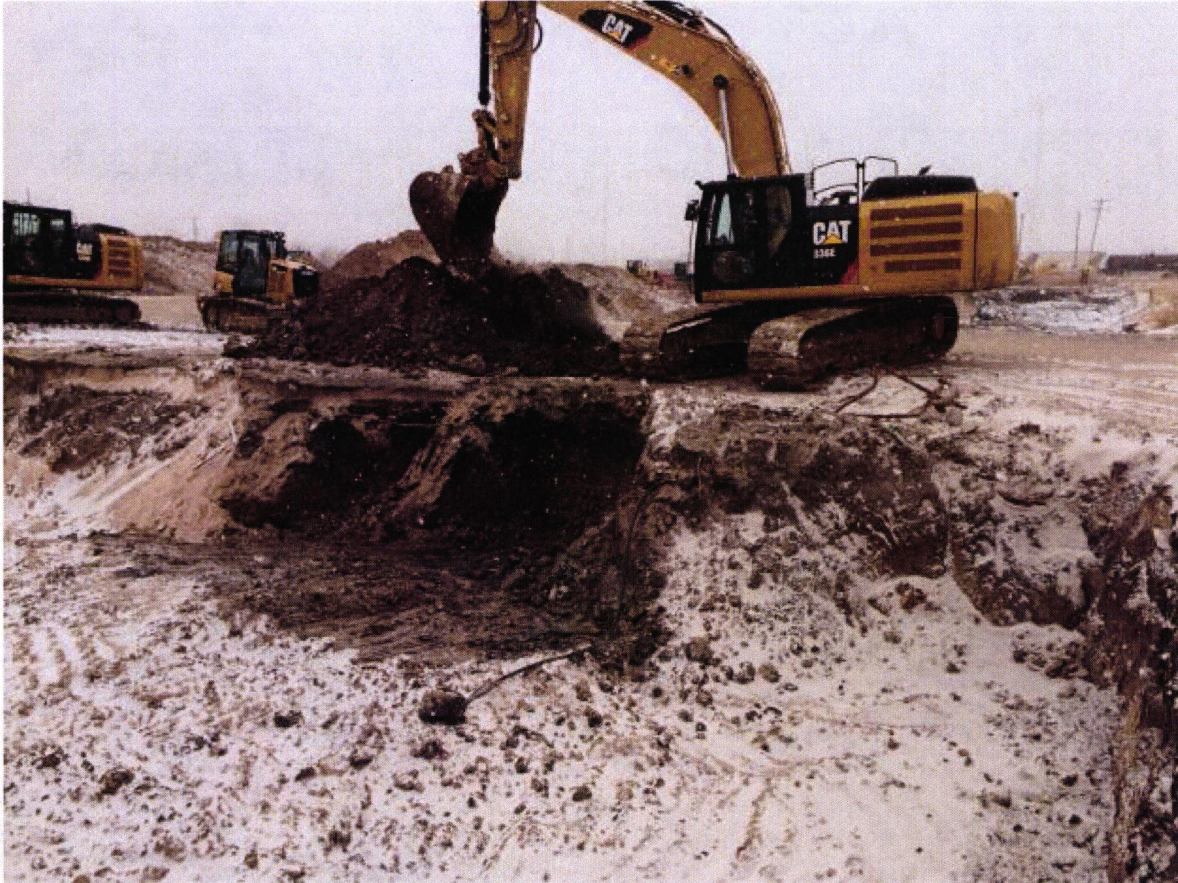
Looking Southwest, the photo above shows the drums and rubble being excavated from the western wall of the Process Area excavation on December 30, 2015. Rubble (concrete, block, wood, etc.) was encountered behind the drums. Limited excavation of the area was completed on December 30, 2015 as to not interrupt truck traffic in the area.

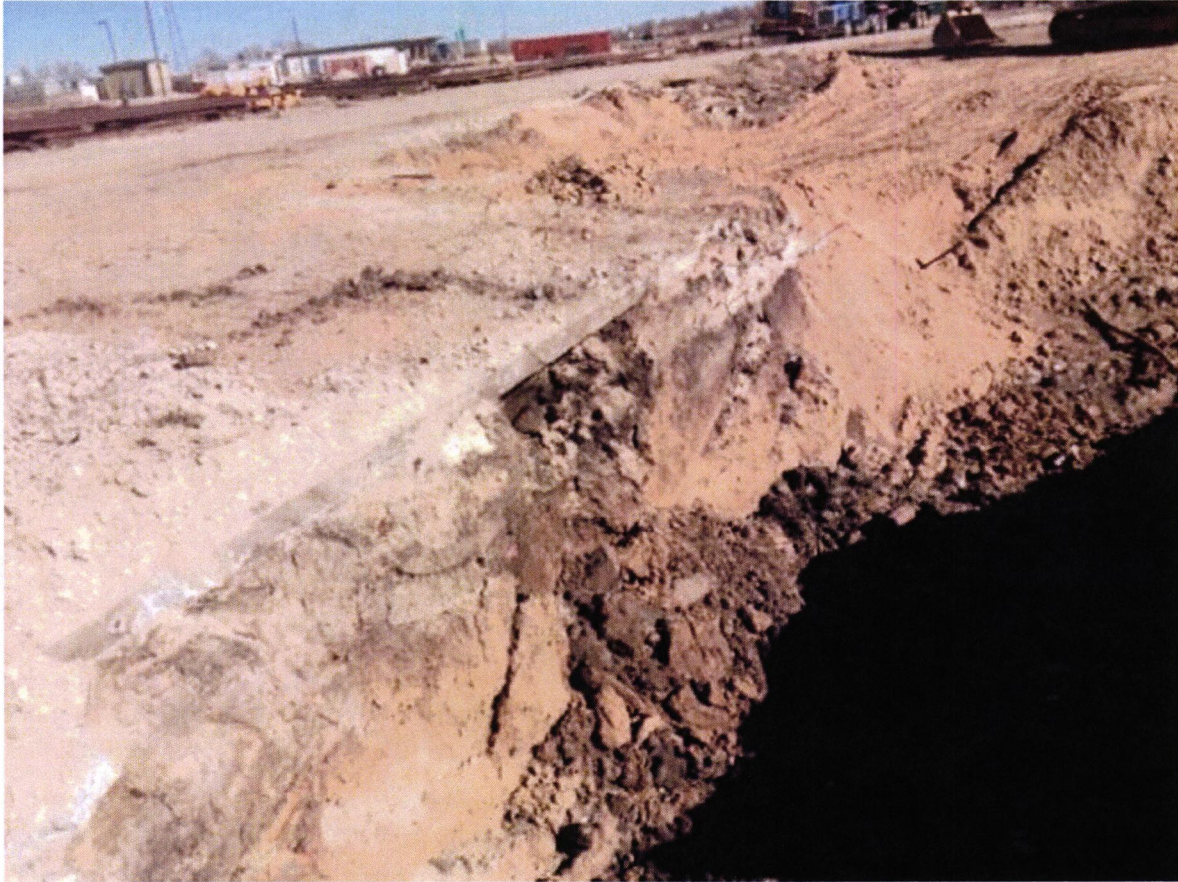
Additional soil was excavated from the location of the drums in the Process Area on January 27, 2015. Photo was taken looking Northeast at the excavation area.

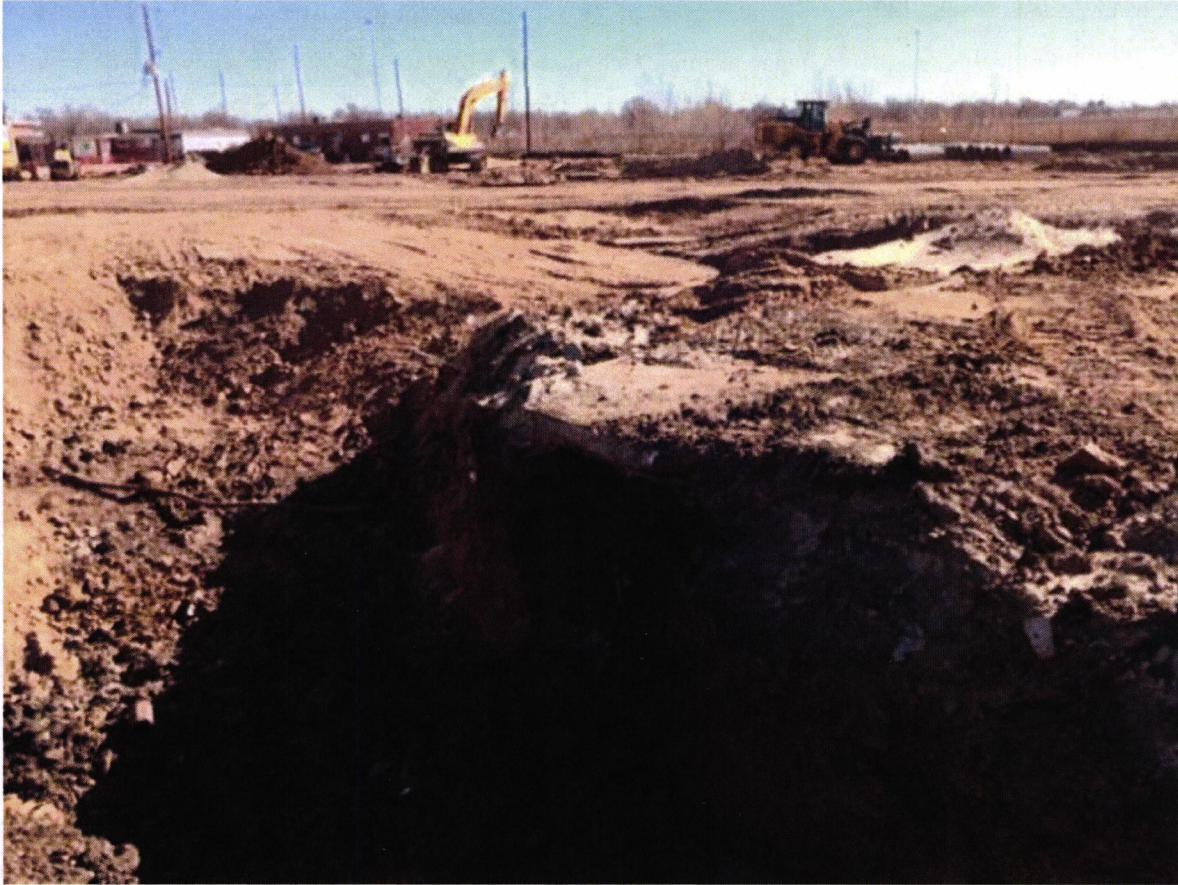
Additional soil was excavated from the location of the drums in the Process Area on January 27, 2015. Photo was taken looking Southeast at the excavation area.

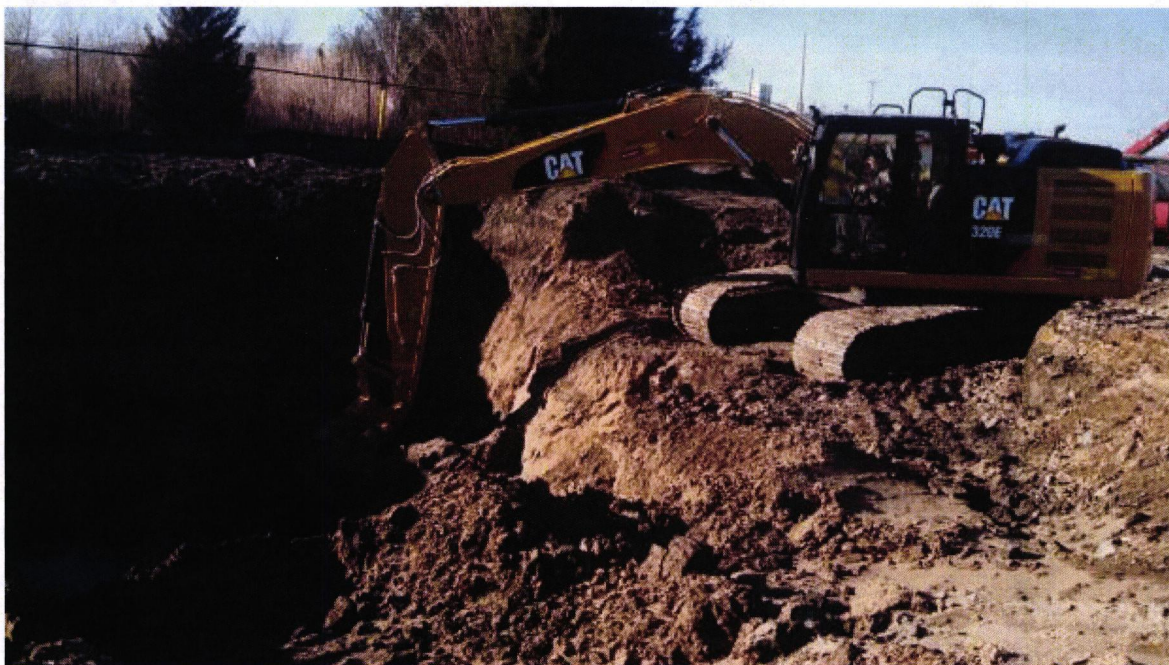
Some Additional excavation was performed on February 2, 2015 where the Western sidewall was excavated further, both removing stained soils and trash/debris and a few drum pieces (highly corroded remnants). Photo taken looking South at the Western sidewall of the paint pit excavation.

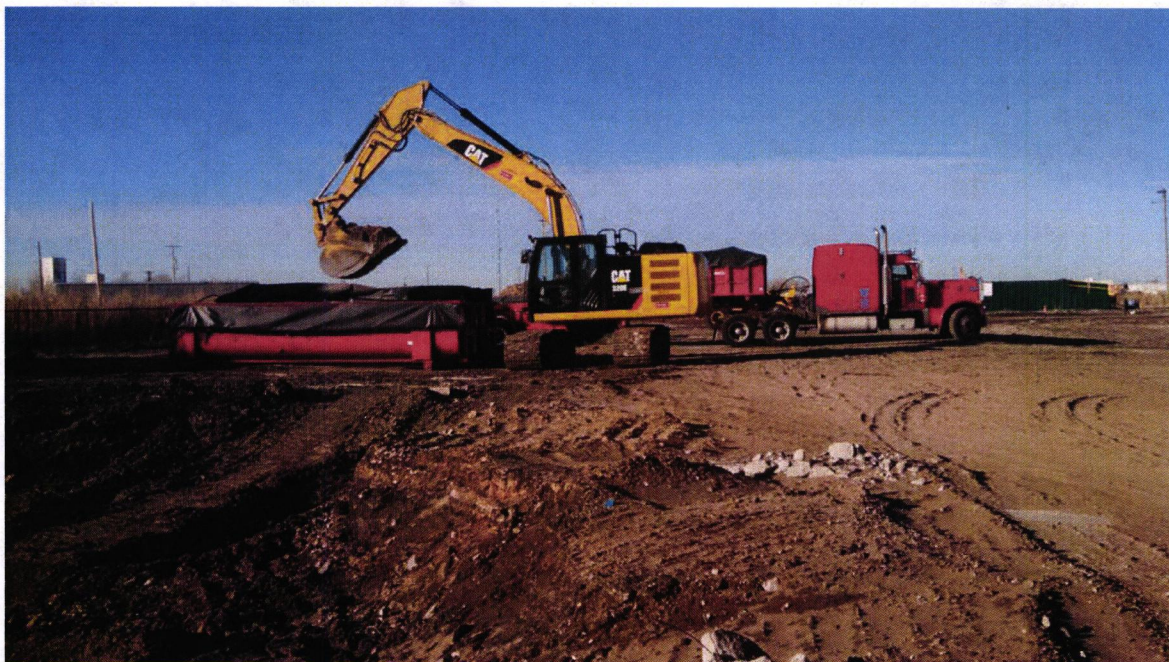
Looking West at roll-off being loaded immediately west of the paint pit excavation area.

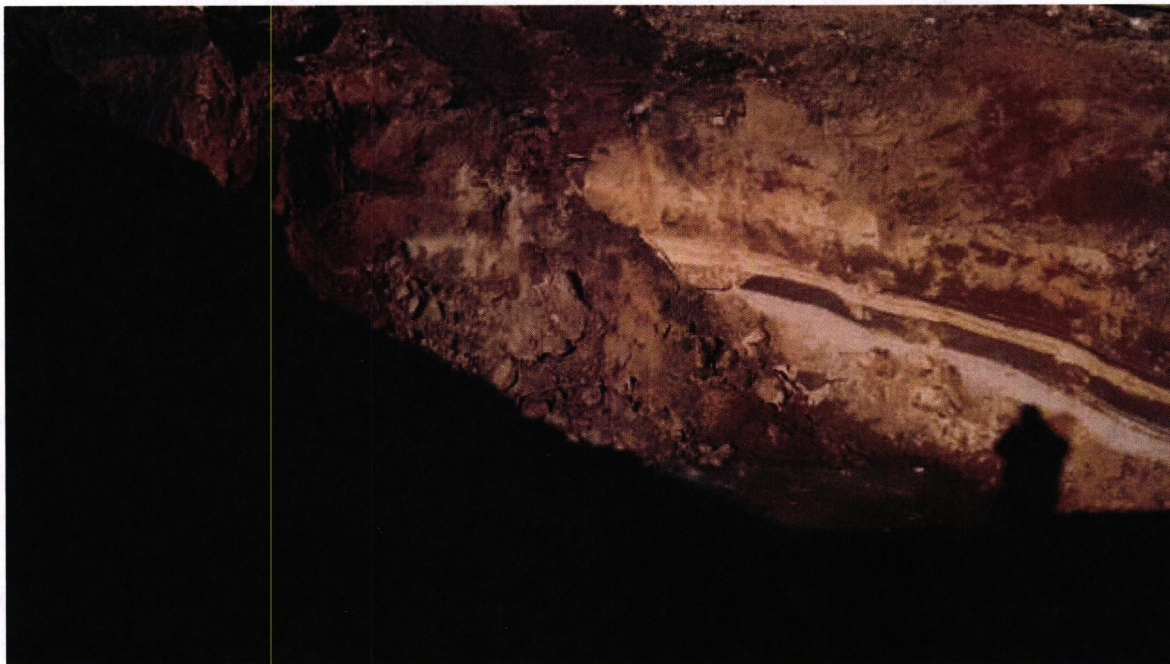
By February 3, 2015 a black stained area and more trash/debris & Drum pieces were evident to the West side of the excavation. Photo taken looking Northwest into paint pit excavation.

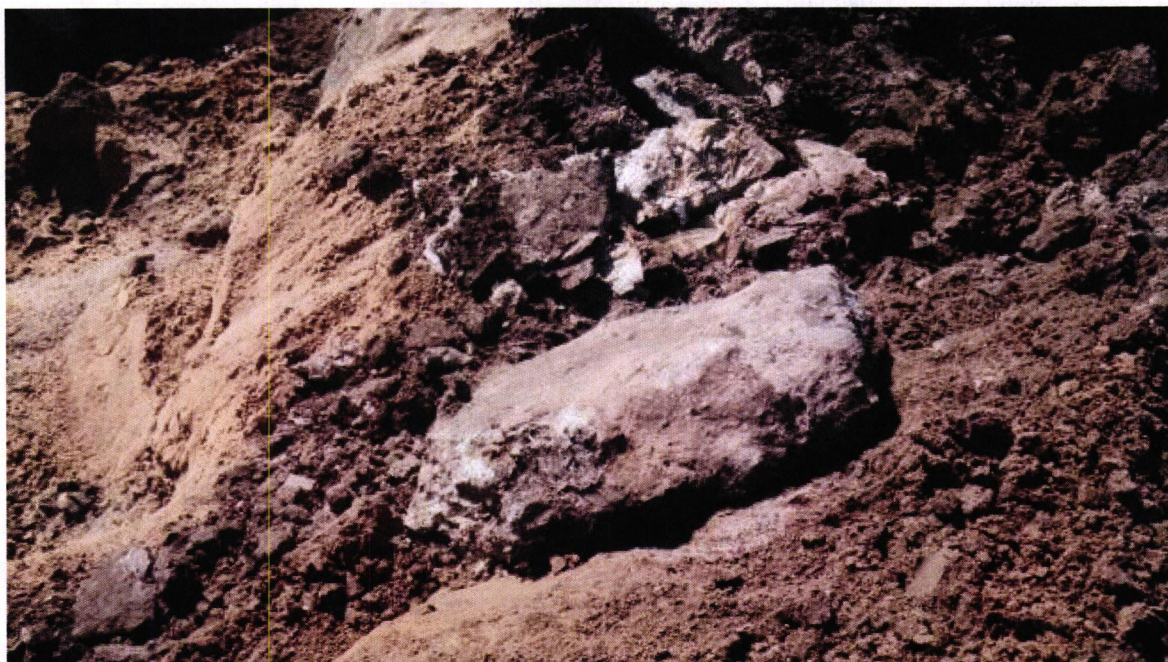
Waste Materials were becoming evident, such as this large piece of suspected Fiberglass material.

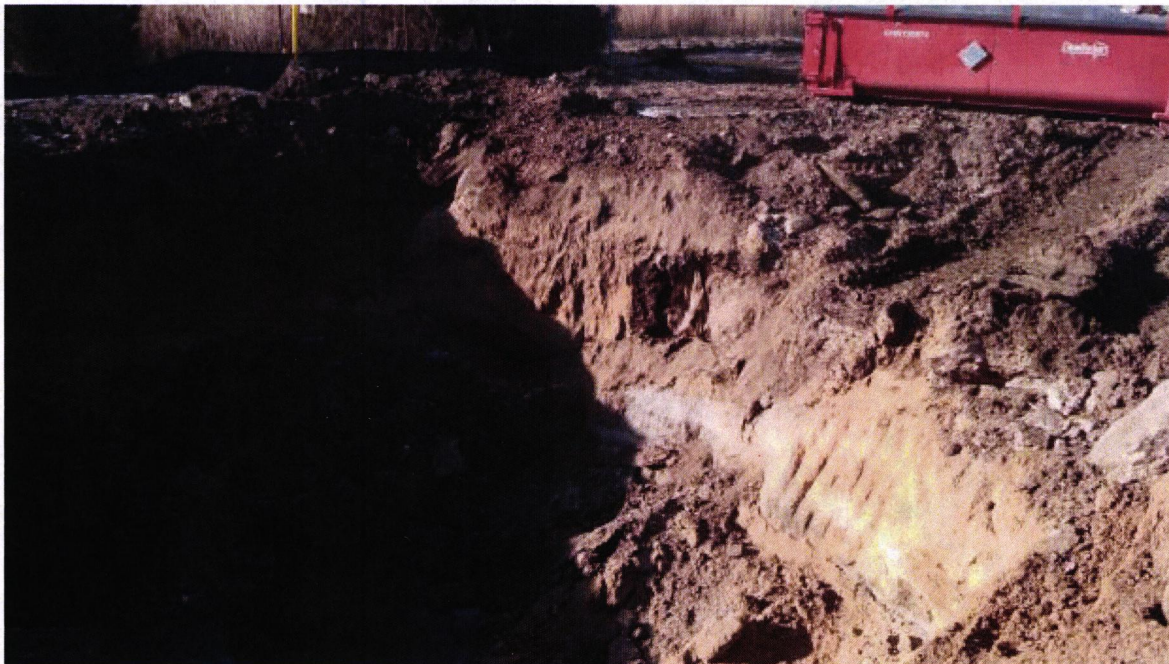
Looking Southwest, the photo below shows the Western sidewall of the paint pit excavation and the dark stained area as seen on February 5, 2015.

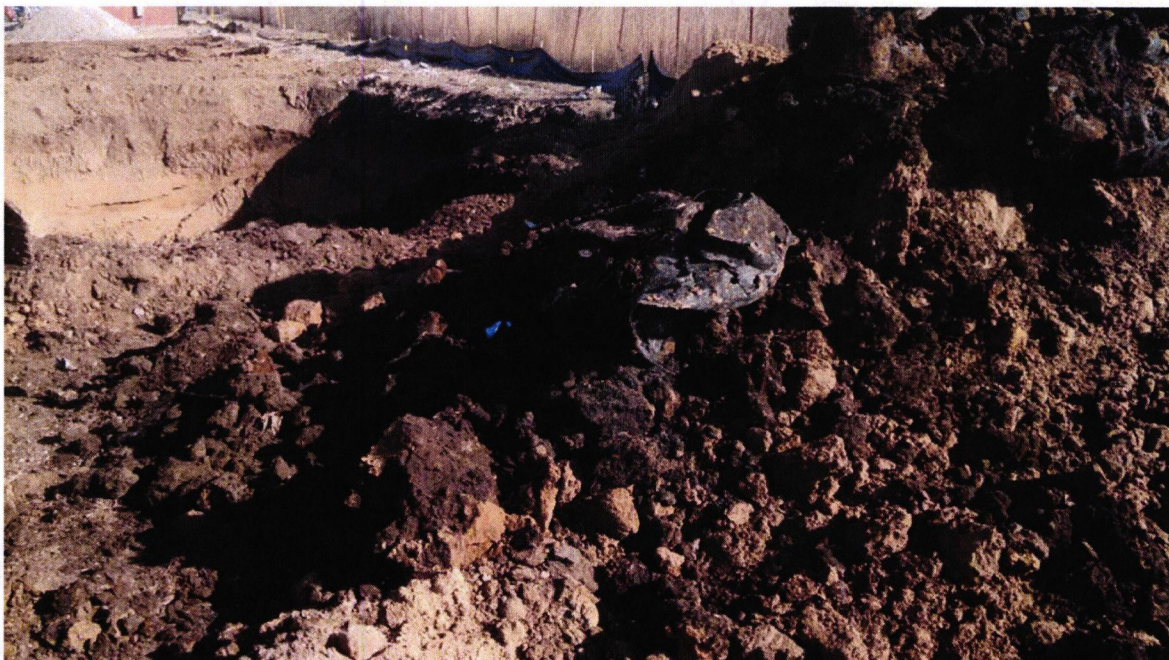
Looking Southeast at the paint pit excavation on February 10, 2015 additional drums were encountered.

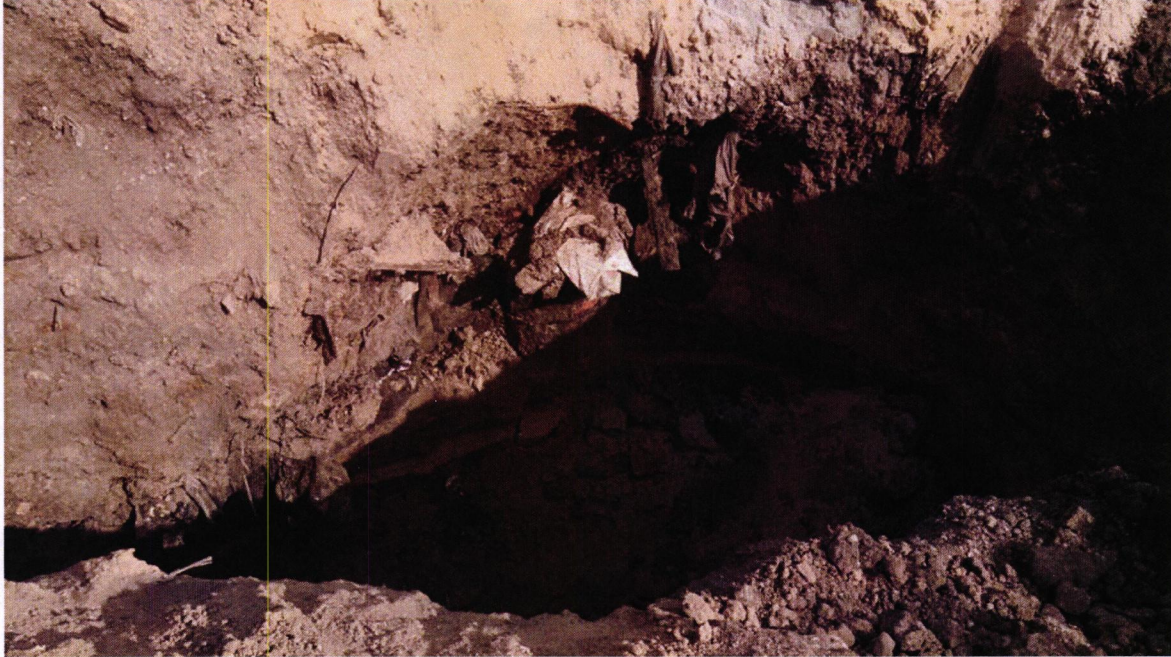
A "pothole" excavation on February 12<sup>th</sup> was completed to the West of the existing Paint Pit excavation in an effort to determine the extent of impacted soils. This excavation encountered multiple drums and drums that were more intact in the ground. Looking Northeast into the excavation, this photo shows a side of a drum beneath white paper trash (shadow falls across the drum).

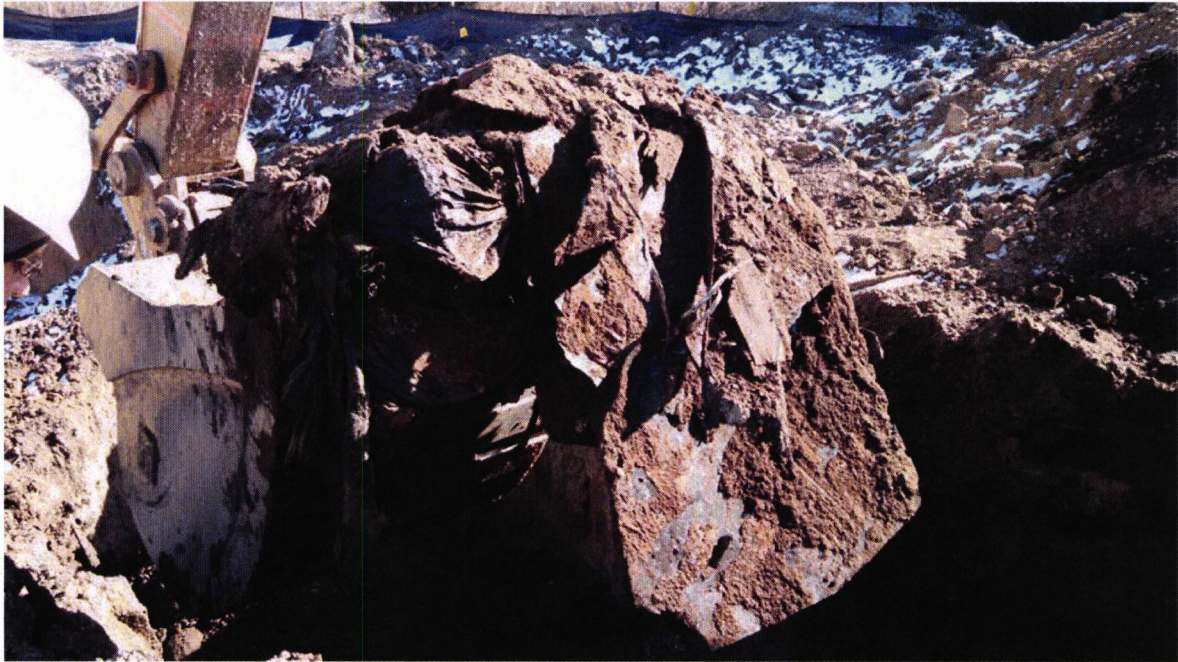
Looking South, additional trash, debris and drums were encountered on February 16, 2015 as material was moved around within the excavation as the extent of drums and trash was searched for, but could not be determined. Photo below is of miscellaneous trash and debris, as moved within the Paint Pit Excavation Western "pothole".

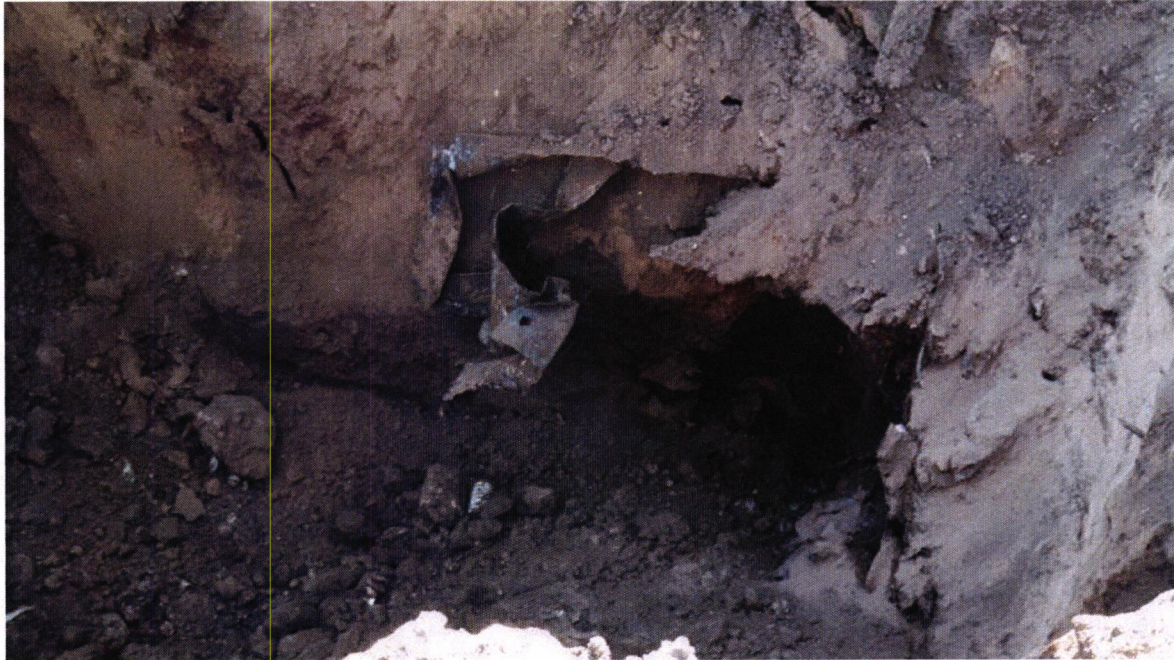
The picture below, looking Southwest, shows a very rare (only one noted) empty drum that still had an inner void space. Generally all other drums were pieces or filled with solids, the majority with what is believed to possibly be fiberglass and/or set epoxy (resin w/ hardner) type material.

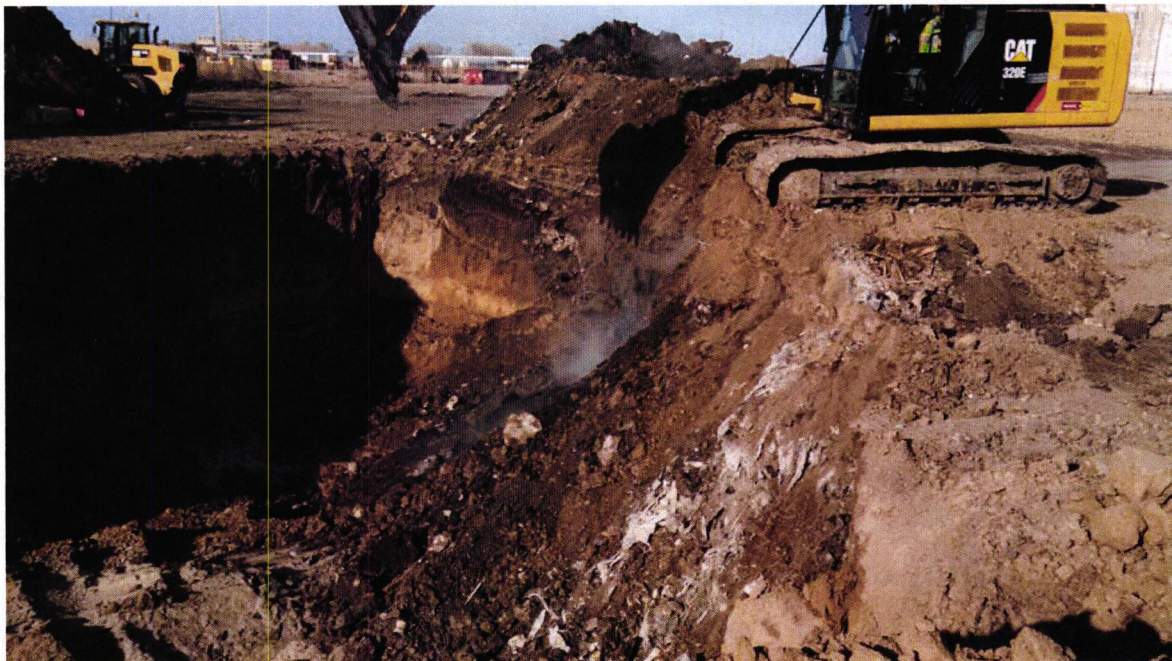
The majority of drums were excavated on February 26, 2015. The following photo, looking West, shows the excavation being extended North and West of the former Paint Pit excavation as drums, trash, and miscellaneous debris continued to be encountered.

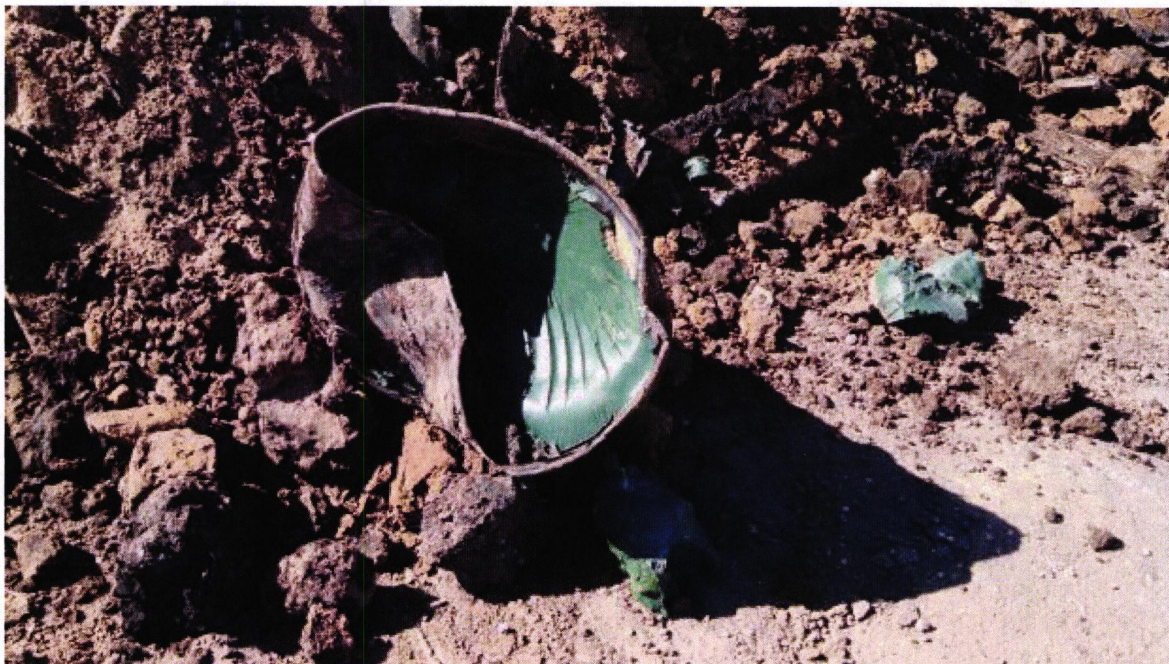
The photo below, looking South, also from February 26, 2015, shows one of the more interesting drums recovered, possibly a drum of green paint that has mostly dried out, the material was hard yet slightly rubbery.

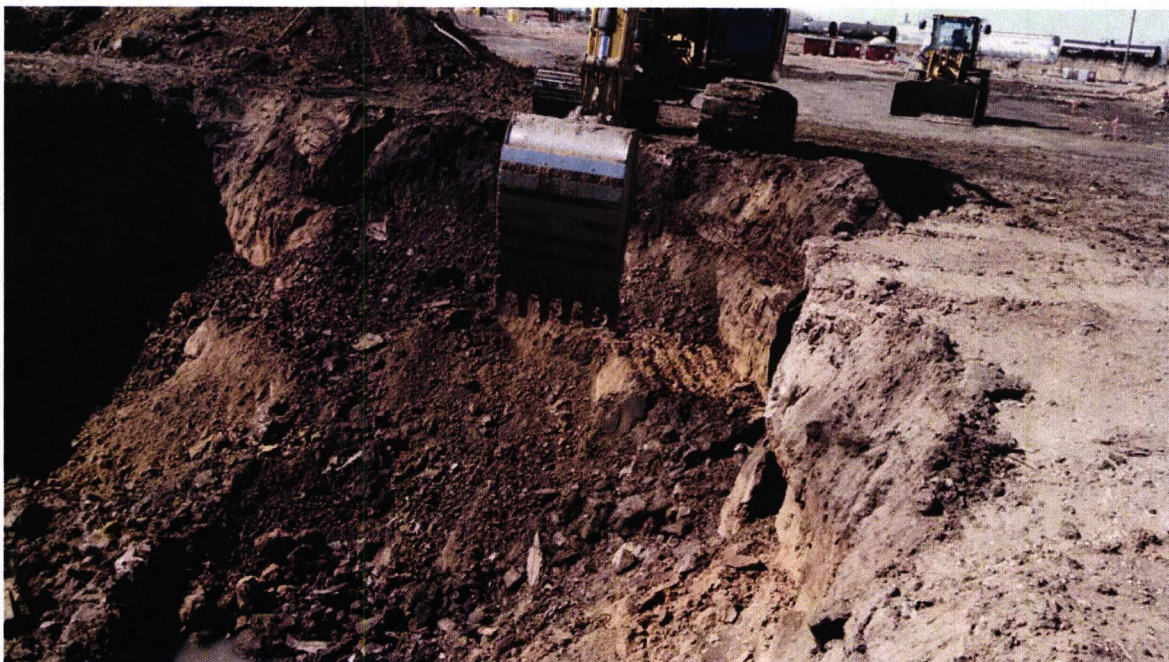
The photo below, looking West, from February 26, 2015, shows the paint pit excavation as it is nearly complete with all drums and waste materials removed, prior to final confirmation sampling.

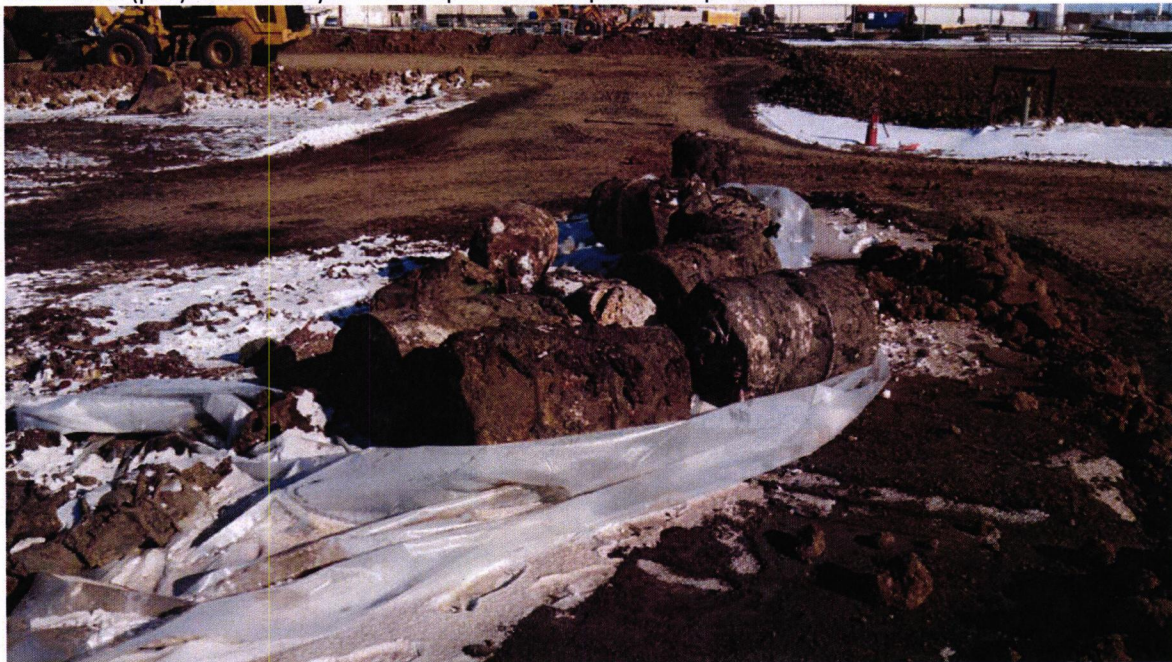
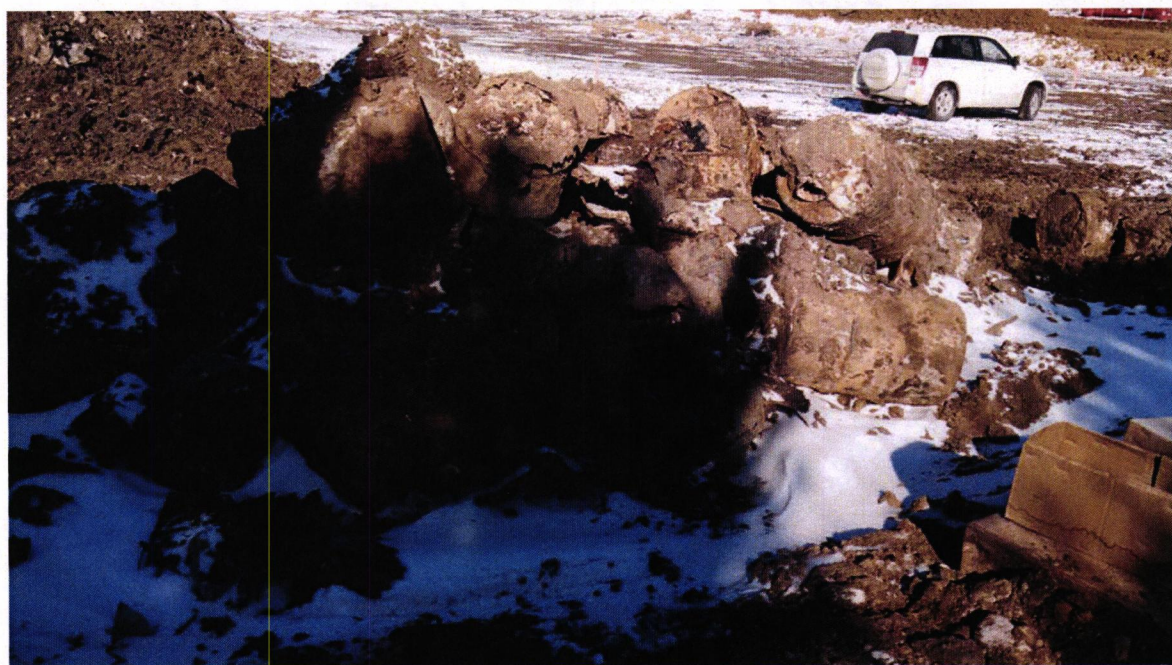
The two photos below show two separate groups of drums separated from the stockpile of soil. Looking North, the first group is placed on plastic sheeting. The second photo is looking Northwest at the second set (pile) which had yet to be separated and placed on plastic.

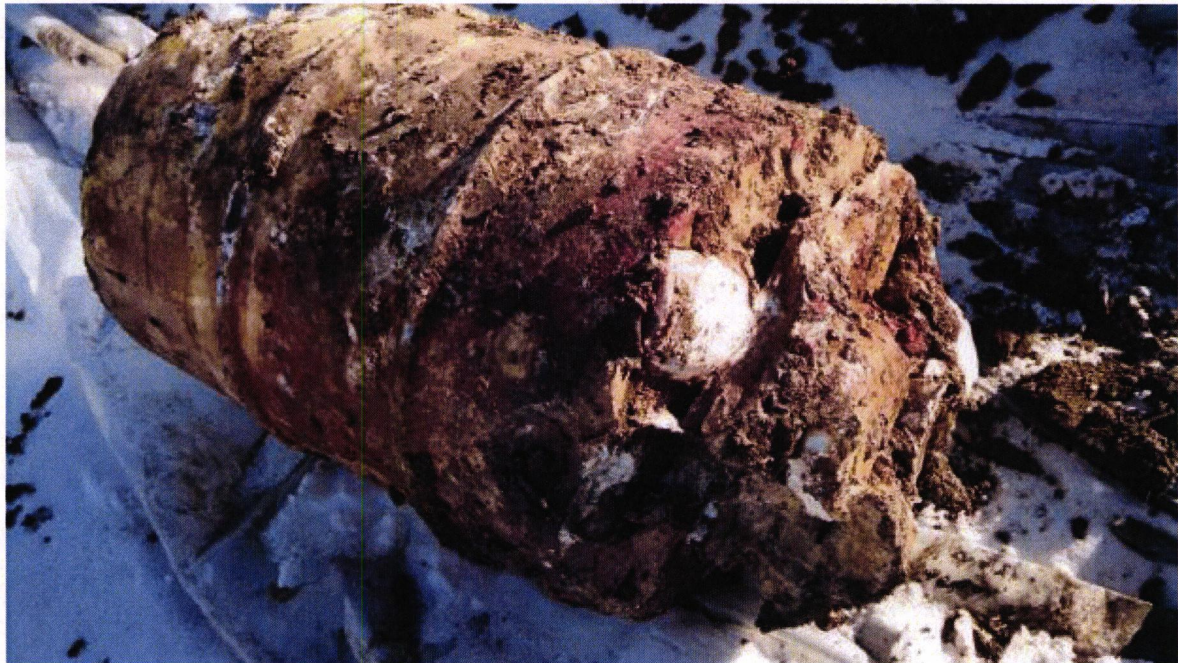
Looking Northeast at one of the apparent drums which was actually only drum contents. The drum exterior had rusted away and/or was removed during excavation. The contents were apparently set epoxy resin / fiberglass type material cast into the classic drum shape. Some of these materials were translucent pink/yellow, while some were solid white.

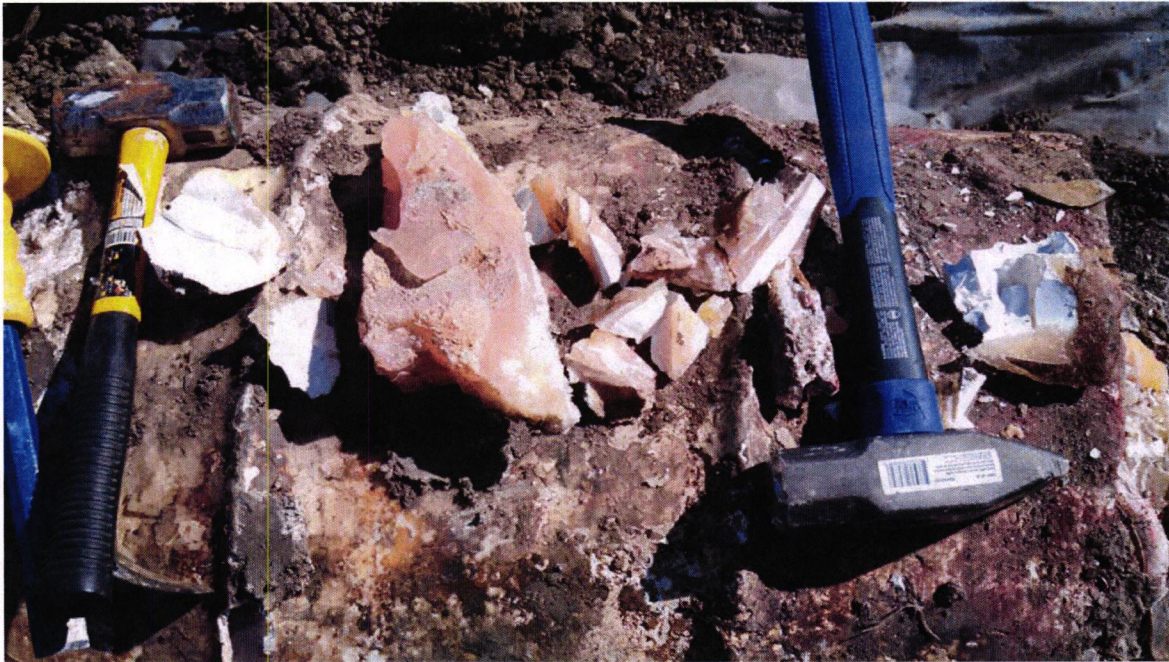
Sampling of the drum contents was accomplished, on March 11, 2015, during a site visit by Chris Jump USEPA. Contents of several of the drums were removed and placed in sample containers. Set epoxy drums required hammer and chisel to break the material down to place in sample containers.

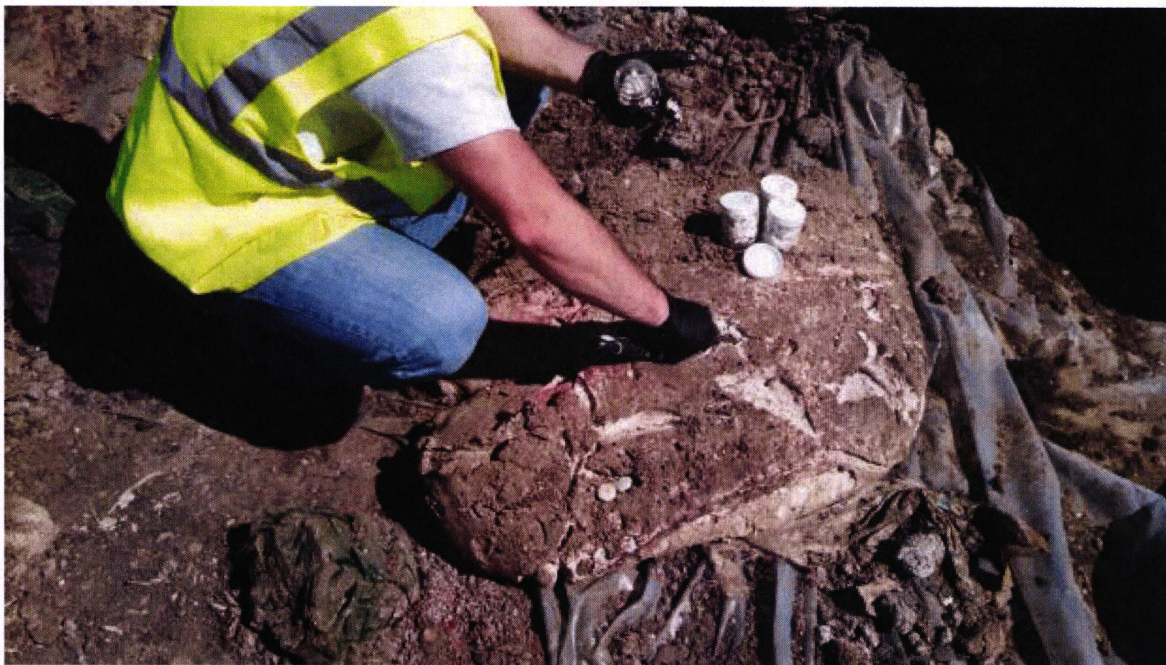
Warmer temperatures were also observed during the March 11, 2015 sampling event. The increase in the ambient temperatures thawed some of the drummed materials, which were previously thought to have been hard and solid. The photo below is looking East at a white rubbery mass that seemed like a silicone type caulking, which is being separated into sample containers.

Following sampling the drums and drum contents were placed into a covered roll-off container.

Analytical results have been obtained and disposal of the sampled materials are being planned at the Clean Harbor's incineration facility in Kimball, NE.
